## Energy Storage – Hydrogen injected into the Gas Grid via electrolysis field test

EUDP 13 – Special Pool Hydrogen

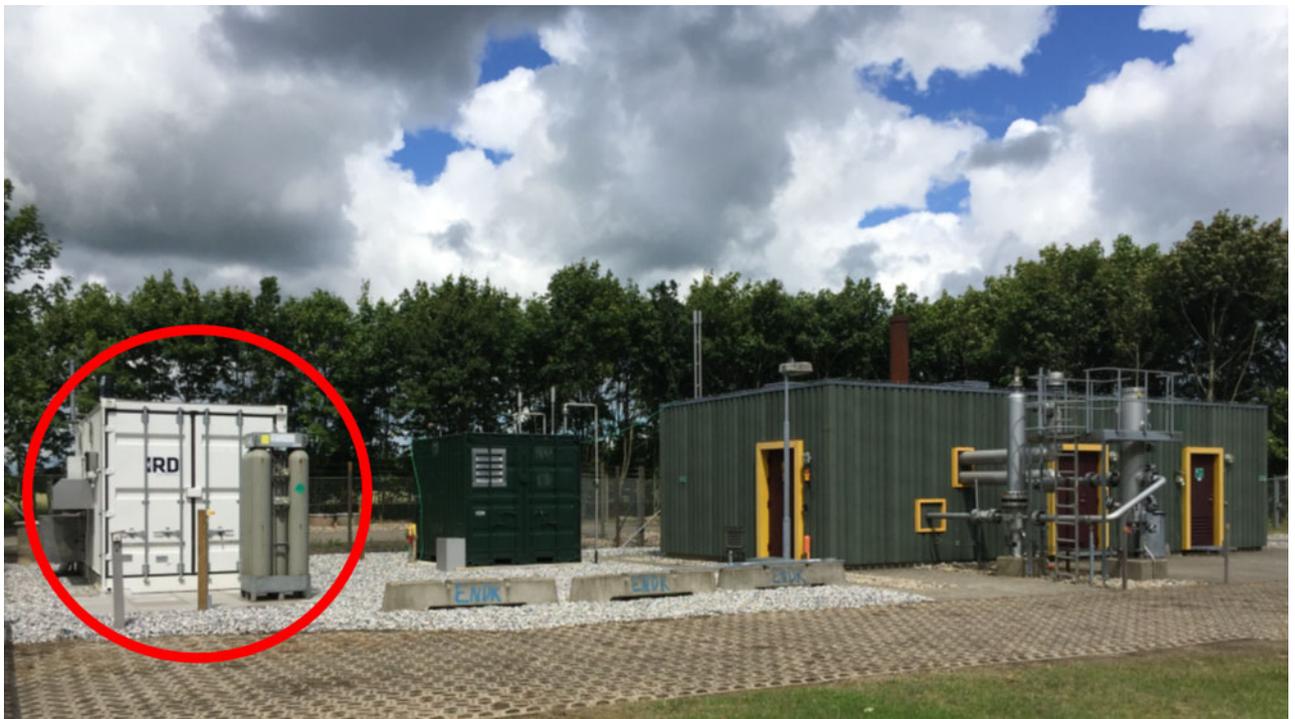
Figure 2. Hydrogen system at M/R Helle/Agerbæk.

The goal was to have an independent and stand-alone hydrogen system on-site.

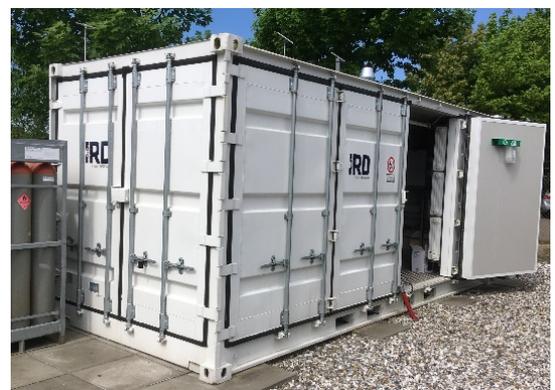
Figure 3. Insulated 20-ft container at M/R Helle in Varde.

ment was kept above 3°C by a radiator reusing the produced excess heat from the electrolyser and the  $\mu$ CHP. An additional electrical heat panel was added as well ensuring reliable operation of the system.

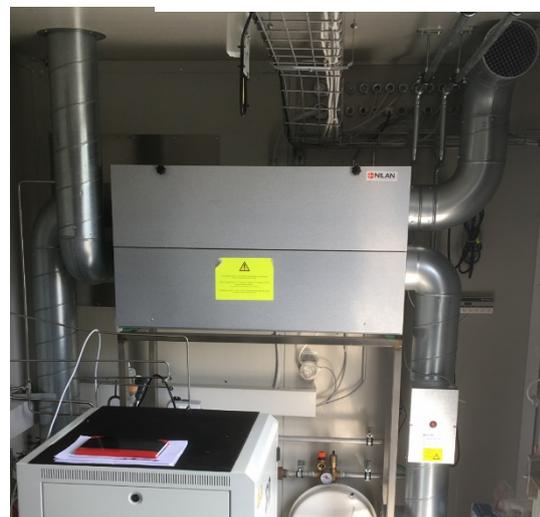
Figure 4. Ventilation system with heat exchanger installed in the 20-ft container.

The ventilation system (Figure 4) ensures first of all the inside safety of the container. The ventilation ensures that the hydrogen amount in the container cannot exceed 25% LEL<sup>4</sup> which corresponds to 1% hydrogen in the air. At the same time, the ventilation system must keep down the temperature inside the container on hot summer days or reuse the heat from the air on cold winter days, by a heat exchanger.

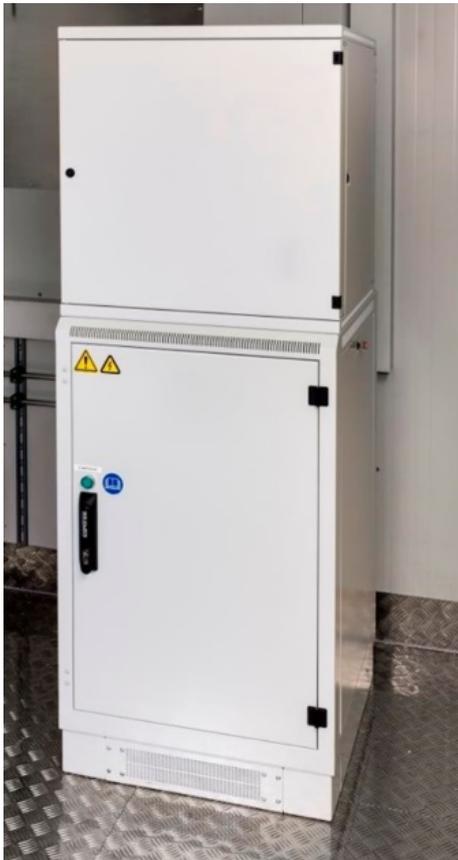
Figure 5. PEM electrolyser with drying system on top.

c) The IRD electrolyser and H<sub>2</sub>-drying system:

The power consumption of the PEM electrolyser is 5.5 kWh and of this hydrogen is produced (75%) and heat (25%). The water consumption is about 5 litres per 1 Nm<sup>3</sup> H<sub>2</sub> although the theoretical water consumption is only 1 litre. The electrolyser is fed with >100 times the theoretical water amount. The produced hydrogen of the PEM electrolyser is very wet and cannot be stored in this condition. For that reason, the hydrogen passes a drying sys-

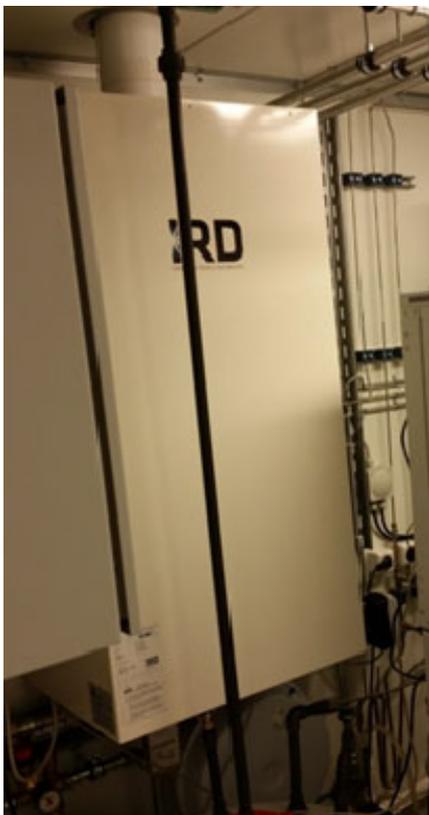
Figure 6.  $\mu\text{CHP}$  as wall installation.

The  $\mu\text{CHP}$  shown in **Fejl! Henvisningskilde ikke fundet.** has also been developed and produced by IRD Fuel Cells. The system is not directly necessary for the hydrogen production system, but it makes use of the excess hydrogen production capacity of the electrolyser and helps to achieve a longer operation time of the system and consequently more operation experience. The hydrogen consumption is  $0.7\text{ Nm}^3/\text{h}$  at 0.4 barg for the  $\mu\text{CHP}$ , and it produces 1.5 kW pr. hour electrical power and 1.5 kW heat pr. hour. The  $\mu\text{CHP}$  is CE and EMC certified.

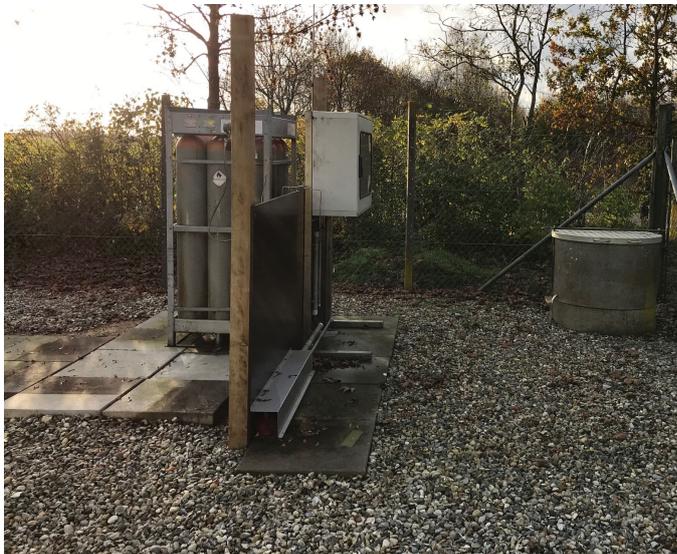
*Figure 11. Picture of the hydrogen storage.*

The hydrogen is delivered pressurized by Strandmøllen A/S. The hydrogen is stored at 200 bar g. The storage consists of 12 bottles with a capacity of 600 litres in total, see Figure 11.

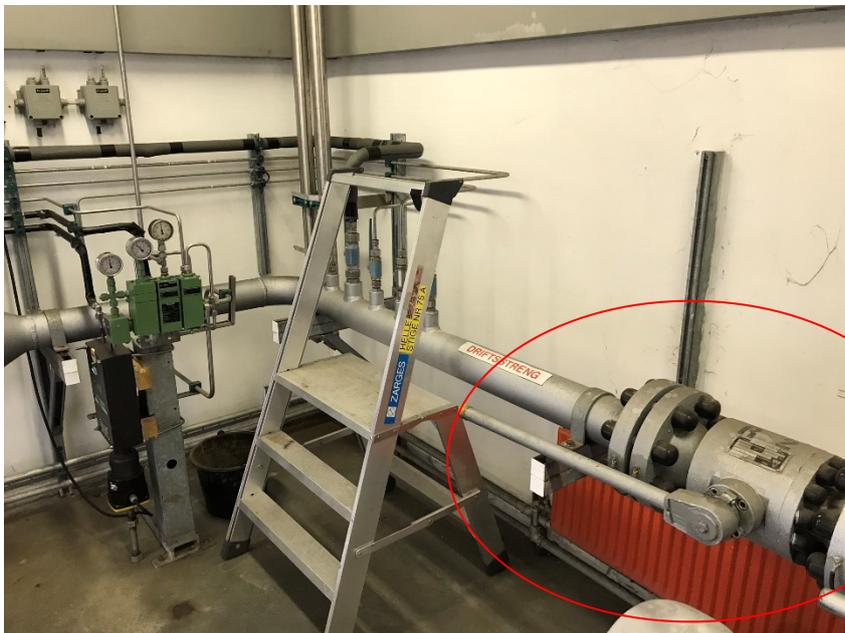
Figure 24. Picture of the leaking valve in M/R Helle.

The leakage was related to a Trunnion ball valve on flow string one, see Figure 24, and was found manually during a weekly check the 6/8/19. The valve was replaced at site shortly after the fault detection.

The hydrogen concentration was decreasing, which indicated a heterogenous leak of the mixture. The valve was diagnosed further, to determine if the leakages were related to hydrogen or not. The result of the inspection indicated that the reason for the leakage was a teared O-ring at the grip of the valve.

The conclusion of the inspection was that the fault was not related to hydrogen. Furthermore, was it concluded that the condition of the valve was fine, and a replacement of the O-ring would prevent homogenous and heterogenous leaks.
